1. STATE COUNTY Town It. Vernon vicinity STREET NO. Mt. Vermanic De Calabana

HISTORIC AMERICAN BUILDINGS SURVEY INVENTORY

2. NAME Myrtle Grove - "Joe Bound S-33 STYLE Colonial ARCHITECT BUILDER

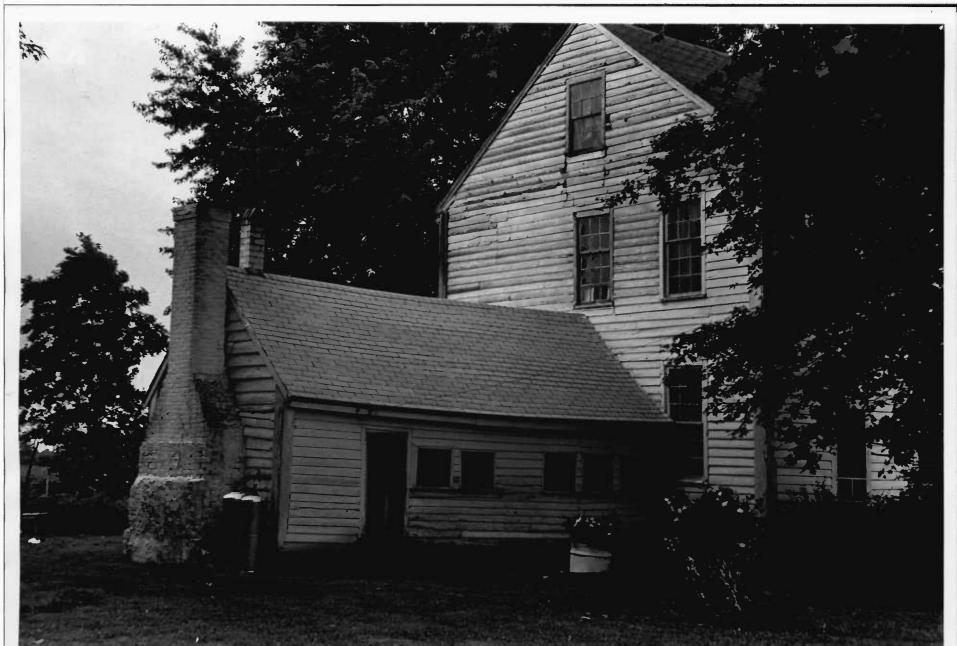
7. PHOTOGRAPH

This house, though unrestored, is in excellent condition. It appears never to have been tampered with and preserves all of its woodwork and most of 'ts hardware. A close watch should be kept on it to prevent its desertion or to prevent any alterations or vandal-It appears to be in need of some structural work, some of the beams and sills are quite rotted.

All original - but probably needs structural work.

5-33 Leave/space before-Myrtle-Grove de Bourd House -5ide viced
